Brief History of Camp Ellis, Maine:

Joseph T. Kelley
School of Earth and Climate Sciences
University of Maine

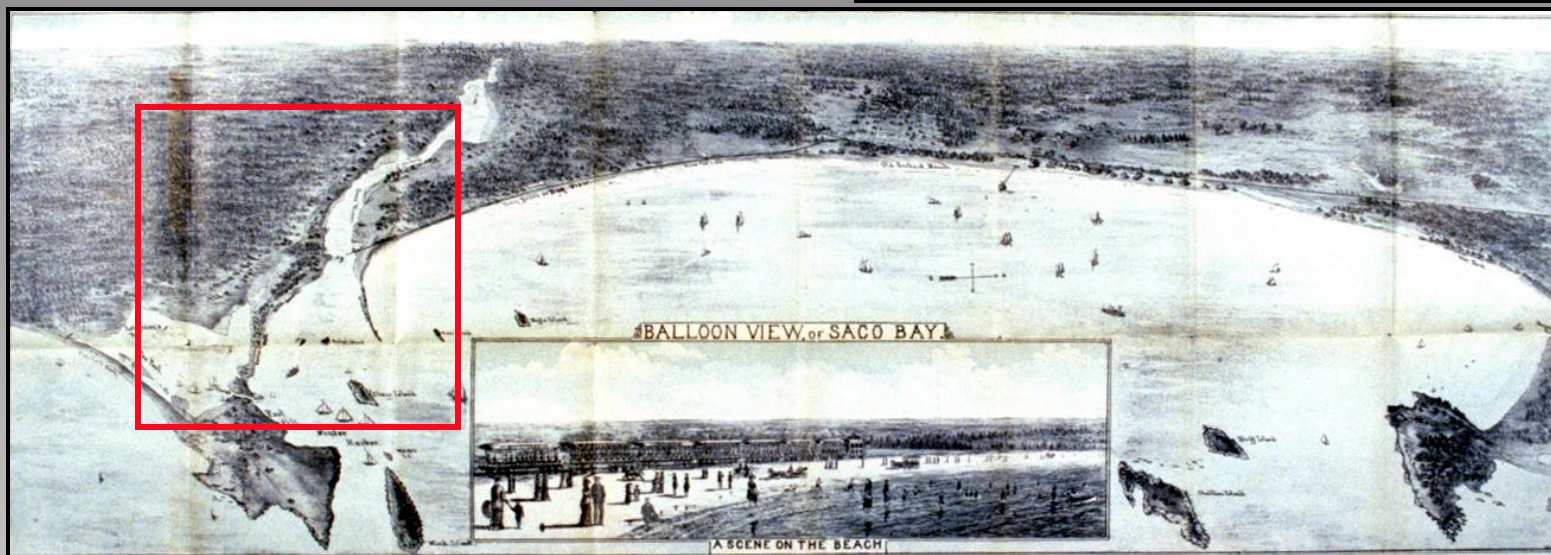
June 30, 1887

proposed
north jetty
extension

proposed
south jetty

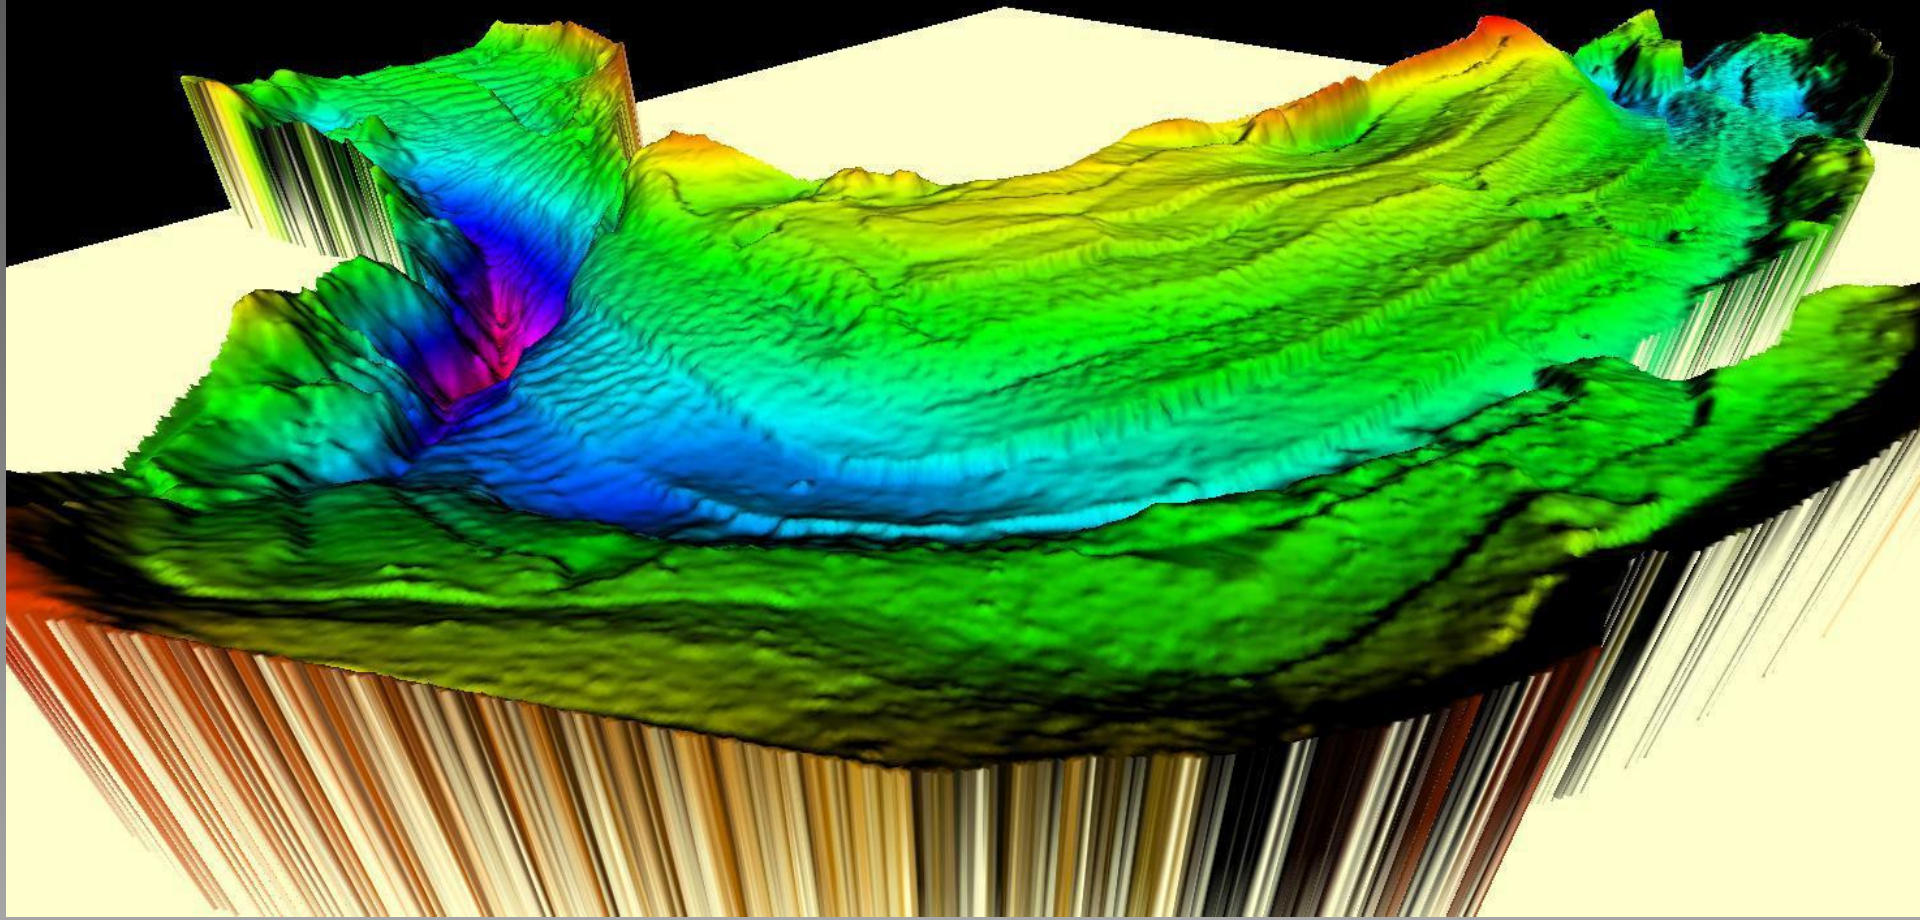
Sand pours through the scour constrictions in large bedforms

**The Army said that “holes” in the Saco Estuary proved no sand was coming downstream;
The holes was bedrock constrictions that led to scour**

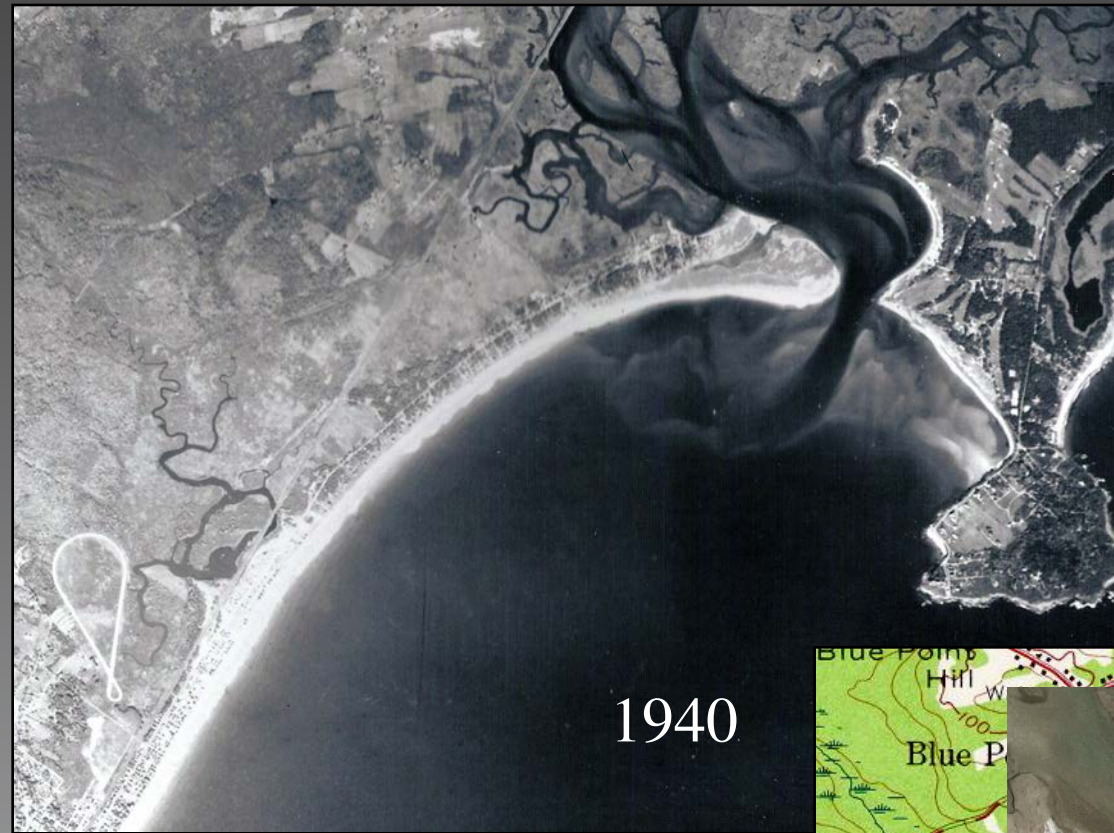
1940

1940-1957: Spit growth

Inlet narrowed by > 500 m since 1877

USACOE jetty in 1957, dredged sand put on spit

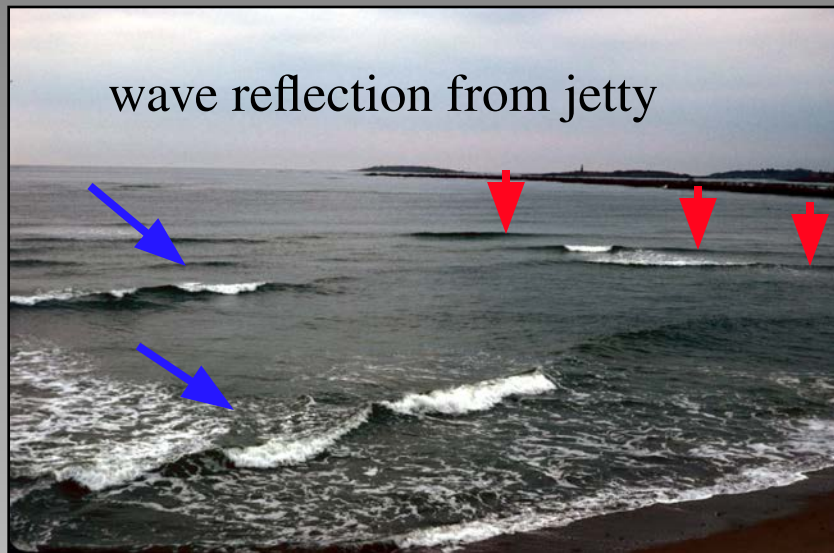
1969:
Camp Ellis beach eroded
Locals claim wave reflection

wave reflection from jetty

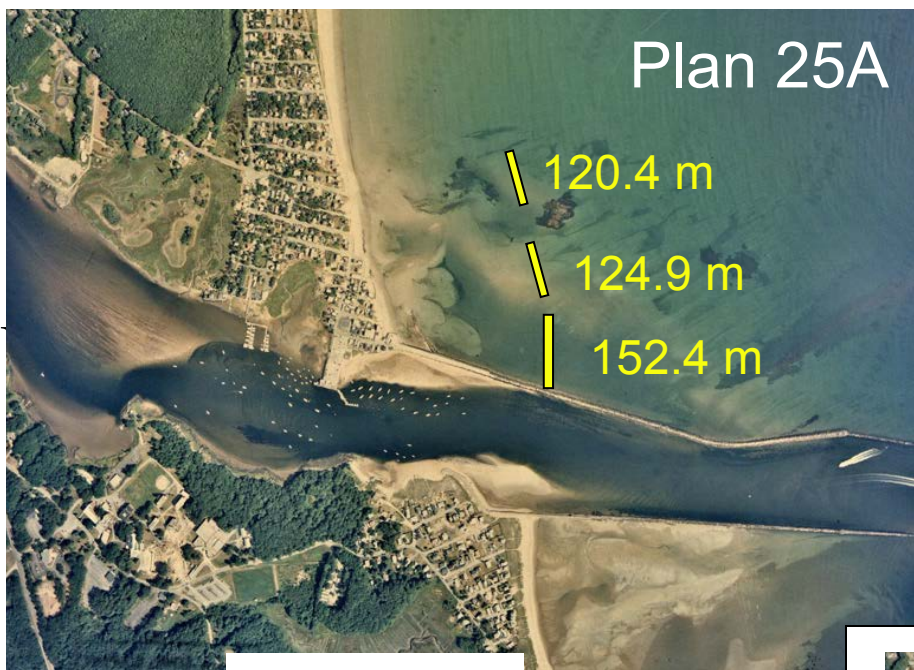
Plan 25A

120.4 m
124.9 m
152.4 m

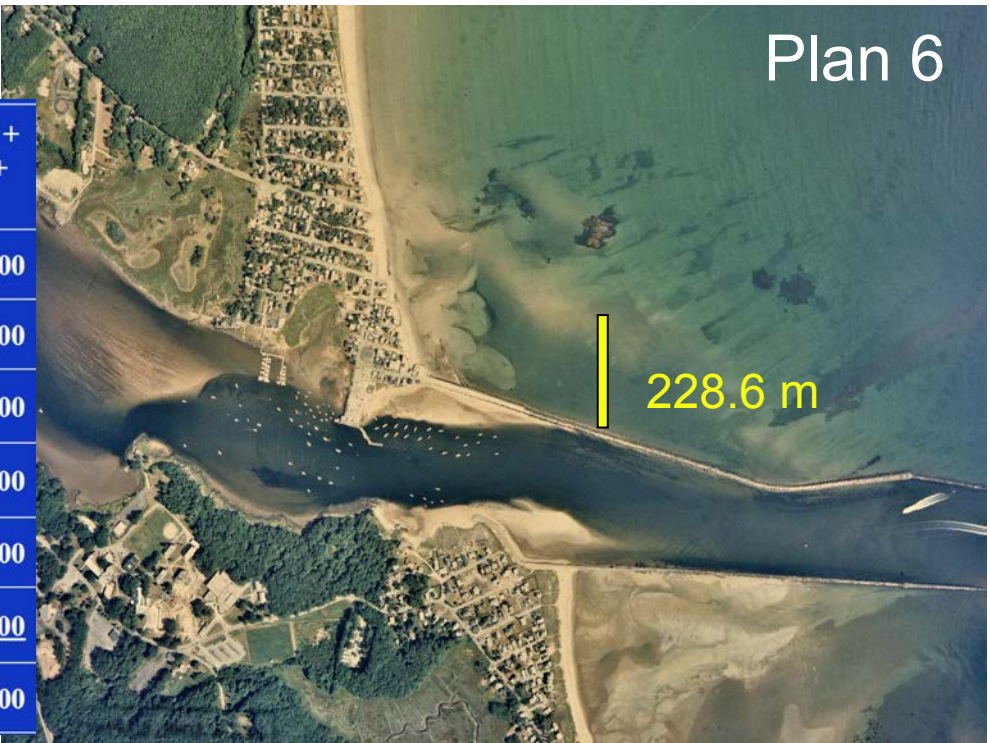
Plan 6

228.6 m

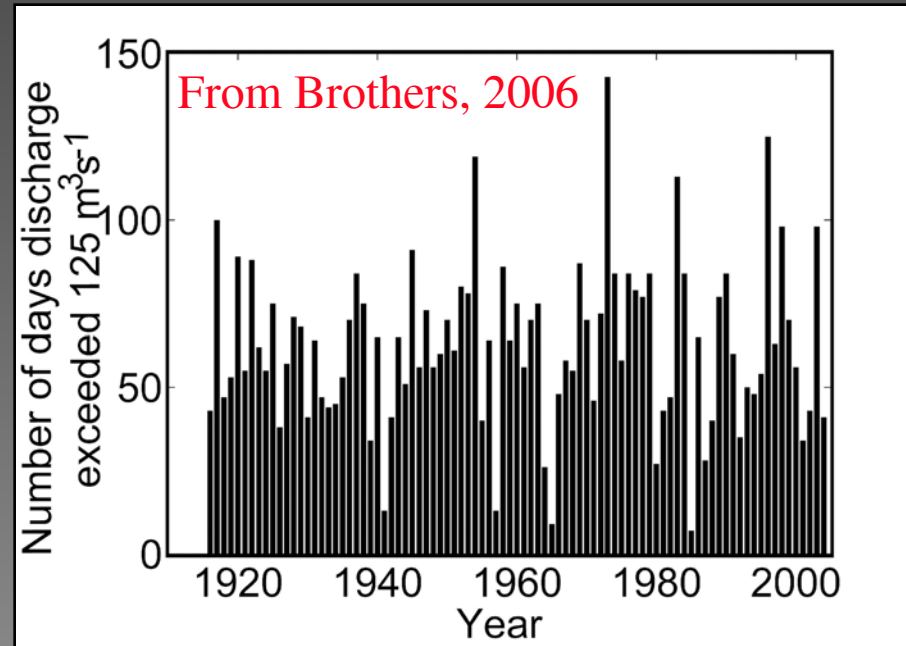
Number of days per year
Saco River contributes sand to
inner shelf

Sand exits river every spring

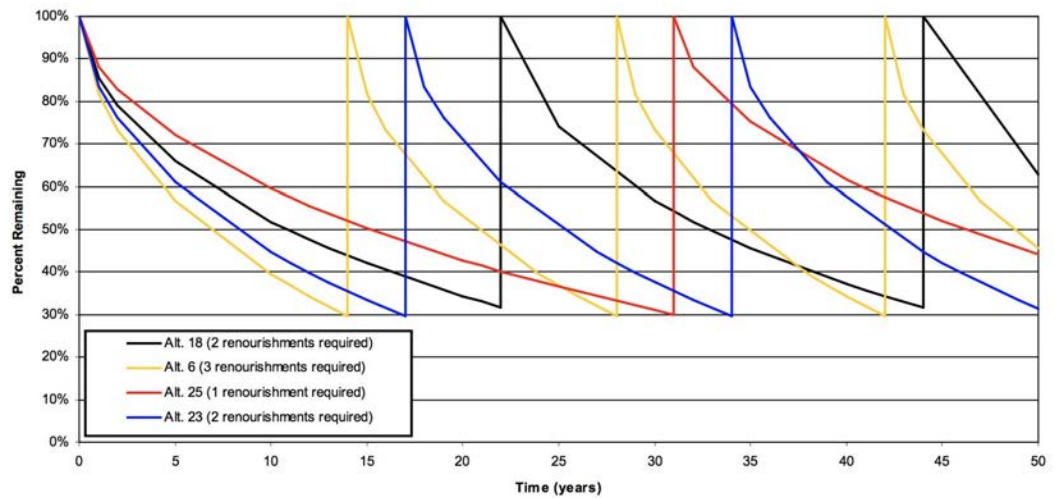
**Figure ES-4
Recommendation**

**Beachfill – 3,250 Feet Long
365,000 CY – Selected Plan (6)
225,000 CY – Federally
Implementable Plan**

**750 LF Stone
Spur Jetty
(Both Plans)**

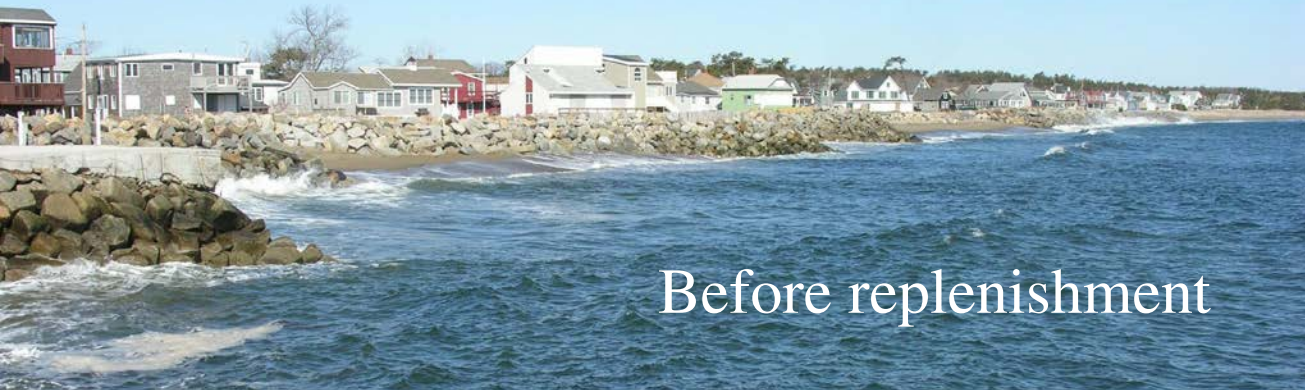
March, 2009

Before replenishment

June, 2019

After replenishment
